NHTSA CONSUMER ADVISORY: Secure Floor Mats in 2007 Lexus ES350, Camry, Other Toyotas; Advisory Also Extended to Other Vehicles

Toyota to Conduct Floor Mat Recall

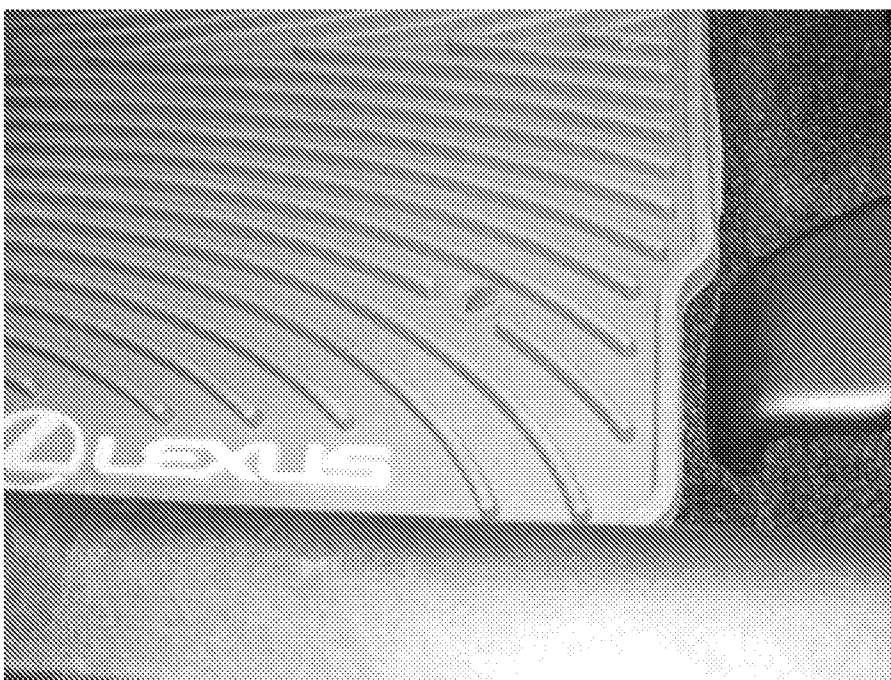
Always make sure your driver-side floor mat is properly secured by the tabs. Never overlay two mats on top of each other because the top-most mat can not be secured properly by the retention hooks.

While the recall is underway, drivers of these Toyota vehicles are strongly urged to make sure the driver-side floor mat is properly secured to the retention hooks on the floorboard. Also, never overlay two mats on top of each other because the retention hooks cannot secure the top-most mat which can then slip and trap the accelerator pedal.
